HISTORIC STRUCTURES REPORT

HISTORIC STRUCTURES REPORT
STRUCTURAL SECTION
PEAVEY PLAZA
MINNEAPOLIS, MINNESOTA

Prepared by: Michael Ramerth, P.E; Elizabeth Kinney, P.E.

July 18, 2016

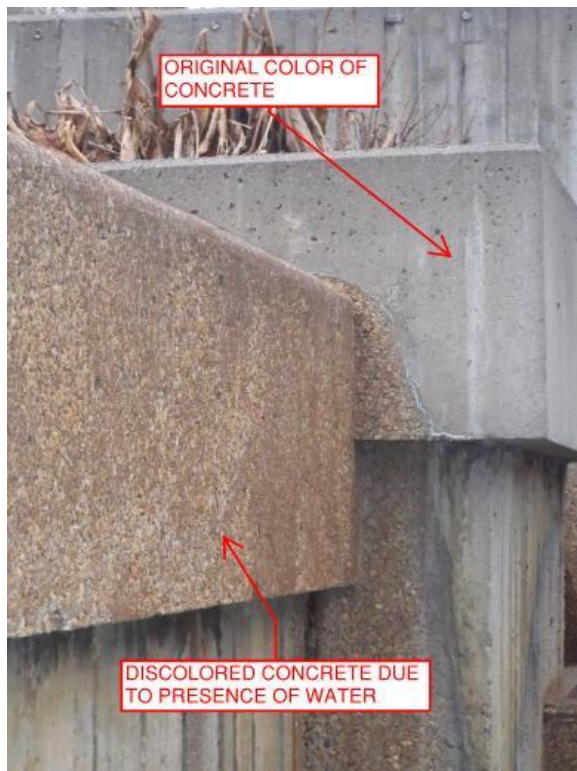
Photograph 3: Concrete color change

Staining: Iron oxide staining was seen at the outer surface of the concrete sample taken at the waterfall. This is consistent with our field observations of the altered color of concrete. This staining is indicative of acidic attack, with approximately 0.5mm of the paste showing surface erosion and stained reddish-brown. This has color change has no effect on the structural capacity of the concrete.

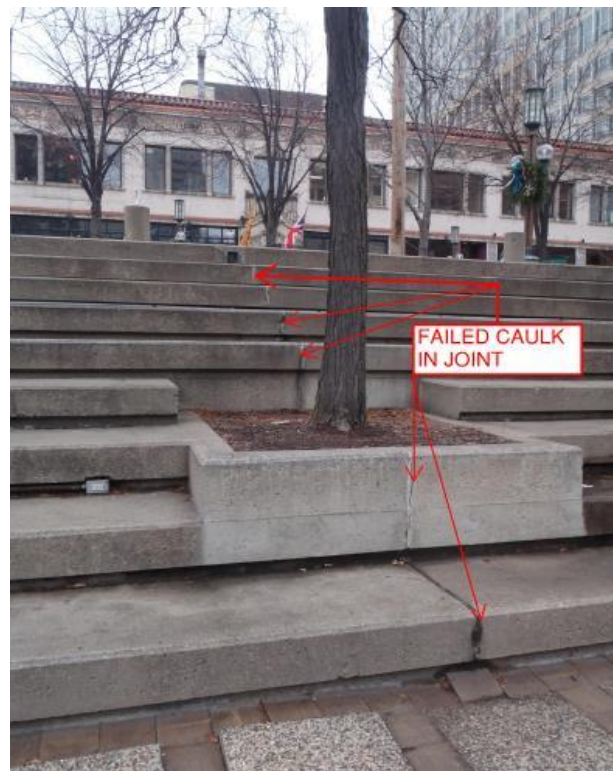
North plaza (corner of 11th street and Nicollet Ave): There are some areas of damaged concrete in this part of the plaza. In several places the concrete stair treads have sections of concrete missing, typically between 2" and 8" in length, see photograph 5. There are also several cracks in the stair treads, typically at corners, see photograph 6. The cracks range in size from 1/16" to 1/4". There are several locations where the caulk in the expansion joints has failed and is in need of repair, see photograph 4.

Photograph 4: Caulk in joint failing

- **Caulked joints:** In any location where the caulk has failed it must be replaced. The type of caulk must be approved and the concrete must be thoroughly prepared per the specifications so the caulk will adhere to the surface, see Figure 4 for the original detail:

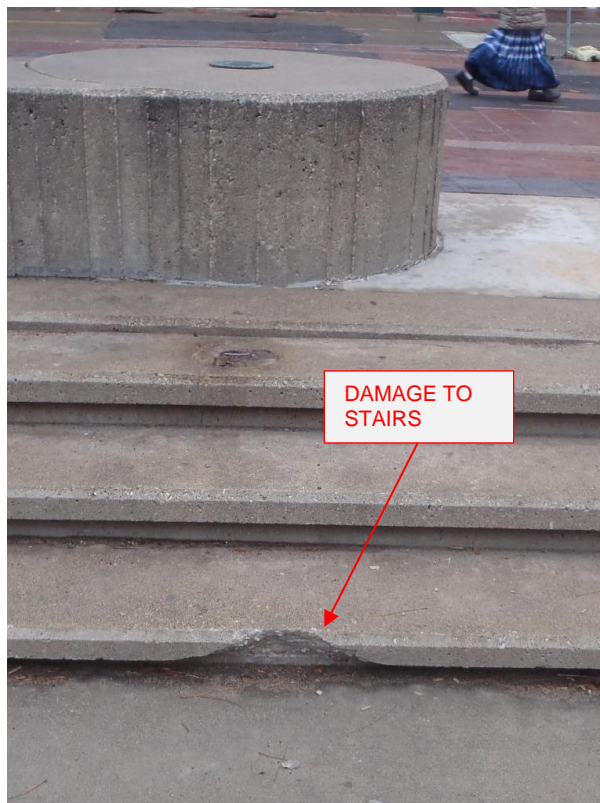
Photograph 5: Stairs at north plaza

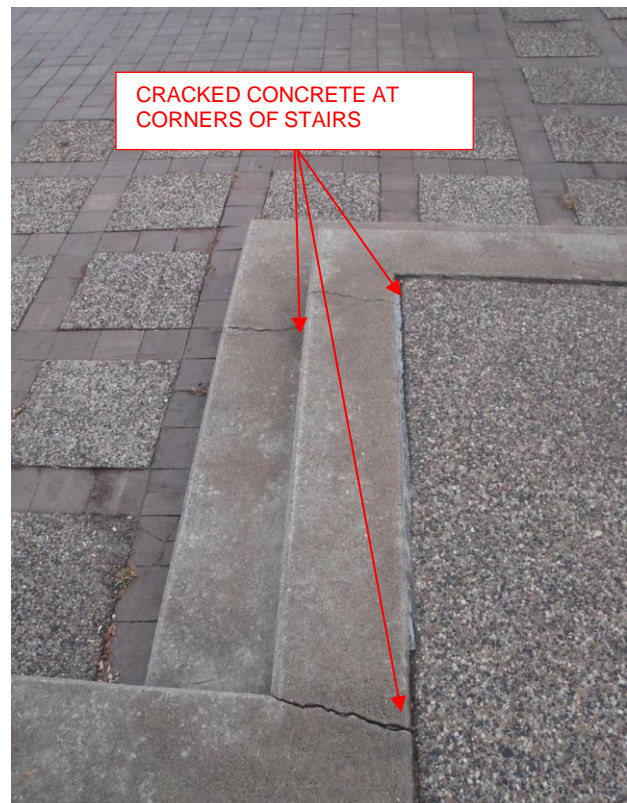
Photograph 6: Stairs in N plaza with cracking

- Stair corners: The cracks at the stair corners are most likely due to the lack of an expansion joint at these locations. It is recommended that the cracks be cleaned, saw-cut straight and then caulked to prevent water infiltration at these locations.
- Concrete discoloration: The discoloration of the concrete does not affect its strength or durability. It is purely an aesthetic choice as to whether to return the concrete to its original appearance or not.

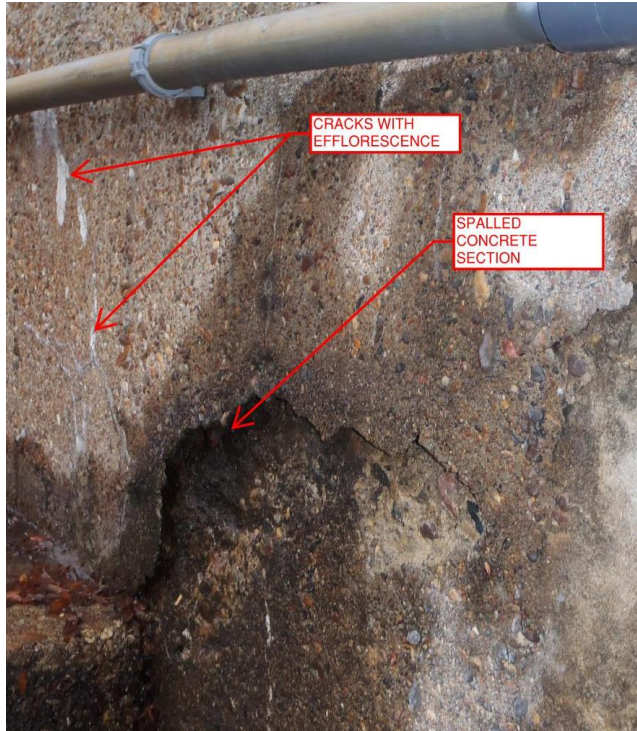
Photograph 7: Damage at East Fountain

- East Fountain: The spalled areas of concrete should be removed and the rebar treated with a migrating corrosion inhibitor. The concrete should then be patched with a concrete of similar characteristics.

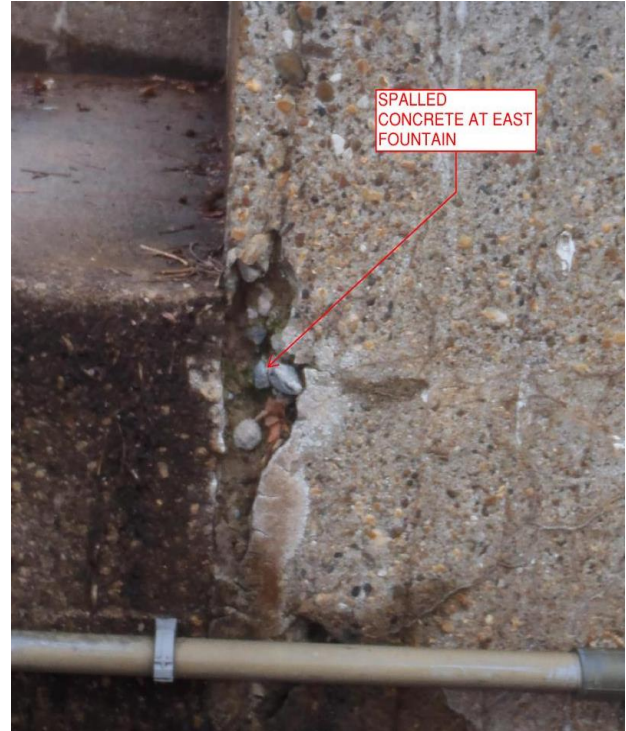
Photograph 8: SW corner of East Fountain

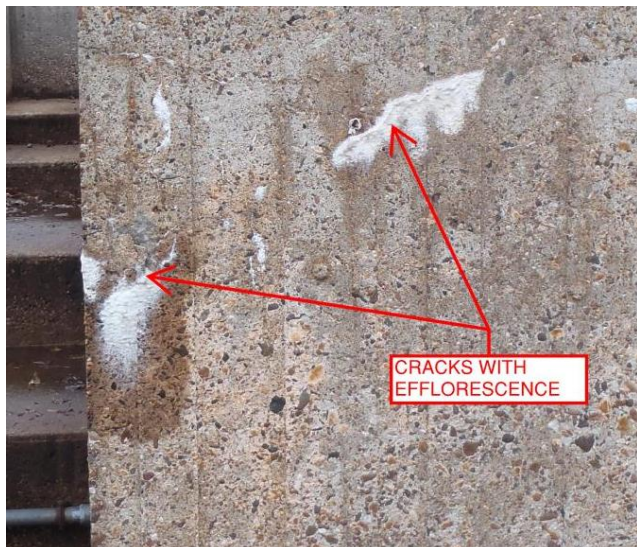
Photograph 9: Cracks with efflorescence

- **Cracks with efflorescence:** The presence of efflorescence indicates that there is water migrating out through the concrete. The source of water should be identified. It is most likely that water soaks into the dirt behind the wall and then leaches through the concrete. From the note 7 on drawing SP-1 it is known that the interior face of the concrete pit structures that contain soil was damp-proofed. It is probable that this surface has failed and is permitting water to migrate. Alternatively, it is possible that there is vertical migration of water through the concrete wall itself, but this is less likely. It is also recommended to determine non-destructively the extent of rebar corrosion at these areas. The level of corrosion will affect the choice of repair.

- **Cracks with efflorescence:** At any crack showing efflorescence it is recommended that the efflorescence be removed according to the National Parks Service Preservation Brief 15 which details the preservation of historic concrete. It is important that during this process the surface of the concrete is not damaged. Secondly, the source of water should be identified and eliminated. This will probably require at a minimum reapplying waterproofing membranes. Thirdly, it is recommended that the level of rebar corrosion be determined as this will inform the type of concrete repair required. If it is determined that the rebar is corroded inside the concrete there are several measures that could be taken to reduce future spalling of the concrete. These methods could include cathodic protection, re-alkalization or application of a migrating corrosion inhibitor.

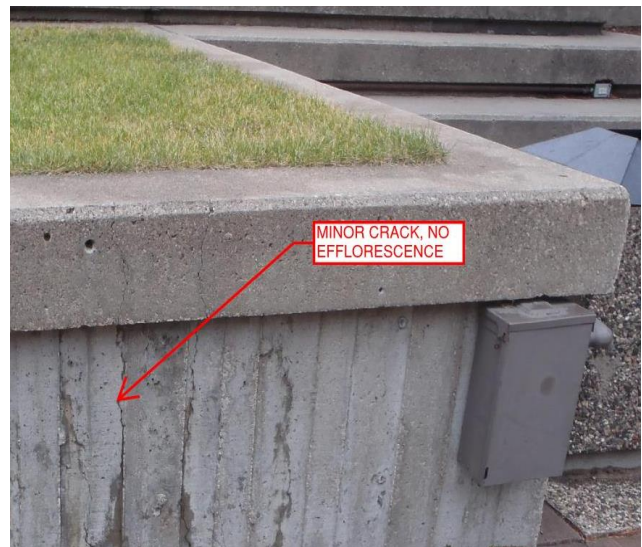
Center West plaza (along Nicollet Ave): This section of the plaza is showing some of the most significant concrete deterioration. Specifically, the lower section of the East fountain has two areas where concrete is spalling, one at the south west corner and the other along the south wall, see photographs 7 and 8. Also, there are many cracks with efflorescence, see photograph 9. There are some minor vertical cracks in the low retaining wall to the north of the fountain, but there is no efflorescence at these cracks, see photograph 10.

Photograph 10: Minor cracks in retaining wall

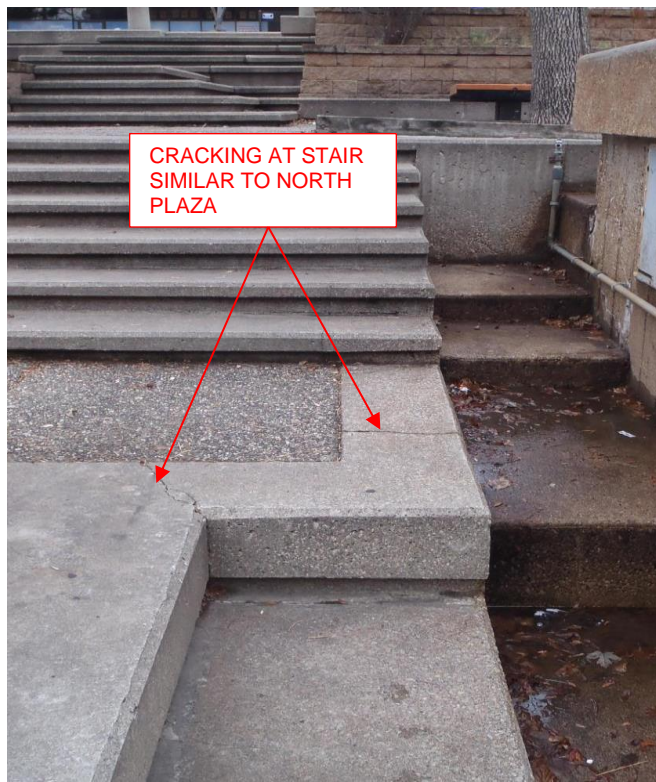
At the stair sections there are cracks at corners similar to those in the North Plaza area, see photo 11. There are also some stair treads that have been damaged and repaired, see photograph 12. At the attachment points of the upper railing along the Nicollet Ave sidewalk the concrete is cracked. At present, the width of the cracks is very small, but it does extend for several feet down through the concrete wall, see photograph 13. Also, in this area there is a crack extending full height at the corner of this retaining wall. The width of this crack is approximately 1/8", see photograph 14.

Photograph 11: Cracks at Stair corners

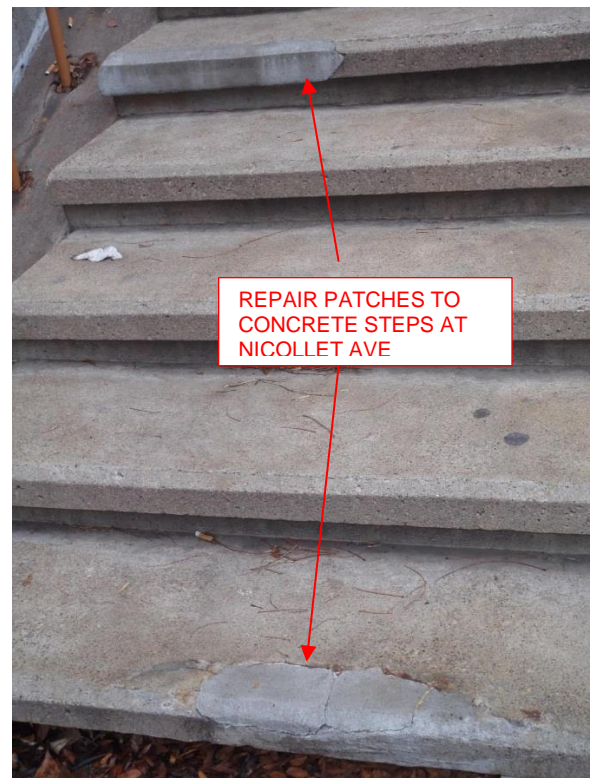
Photograph 12: Damaged stair treads

- **Stair treads:** Several stair treads have damage to their front edge. The concrete in these areas should be removed to 1" behind the rebar and then patched with concrete of similar characteristics.

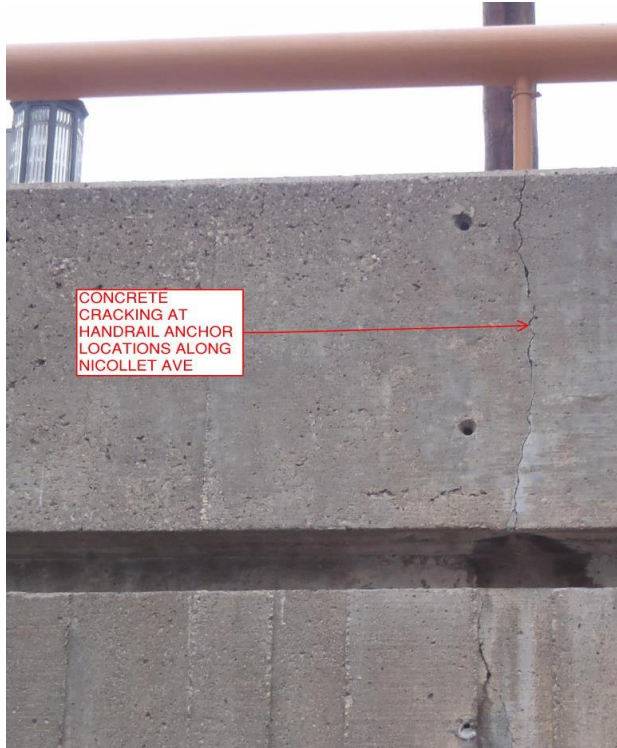
Photograph 13: Crack at railing

- Railing connections at west plaza: The railing detail is shown in Figure 6, and is taken from Detail 5, SP-8. The original specifications for the railing connection in section 0270.8 HANDRAILS AND RAILINGS calls out for “Vertical members shall be galvanized sold steel bars of sizes called for on the Drawings.” The installation is specified to be “Install handrails and railings in previously prepared sleeve as shown on the drawings.... Grout vertical members into sleeves with “Quick-Rok” and sealant as manufactured by Preco Chemical Corp., or approved equal”. It is possible that the galvanizing protection is no longer effective and that the steel is rusting. As steel rust puts an expansive force on concrete, this could be the cause the cracking seen. Further investigation of the railing attachment should be done to determine whether they are the source of damage to the concrete. If so, the railing and sleeve should be replaced with stainless steel, and the concrete repaired.

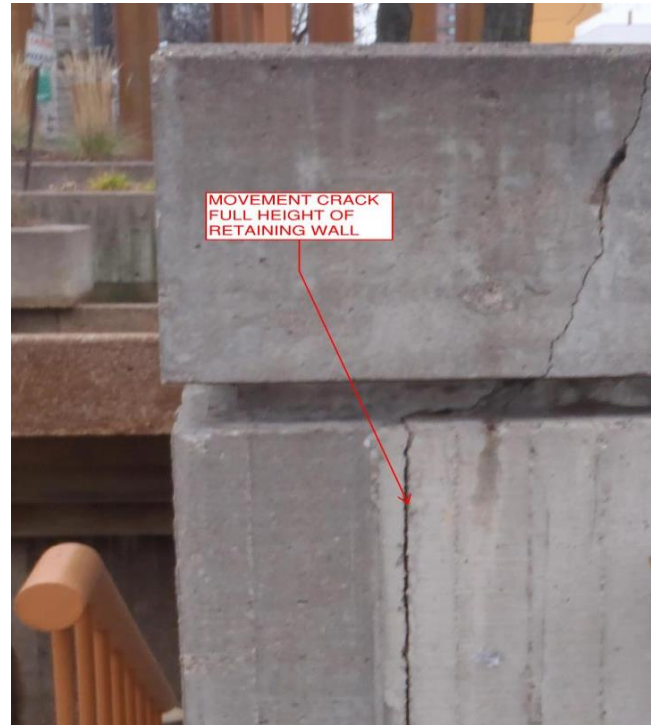
Photograph 14: Retaining wall crack

- Retaining wall in west plaza: This retaining wall has a crack extending almost the full height of the wall at the corner. This is most likely due to differential movement between the walls at the corner.

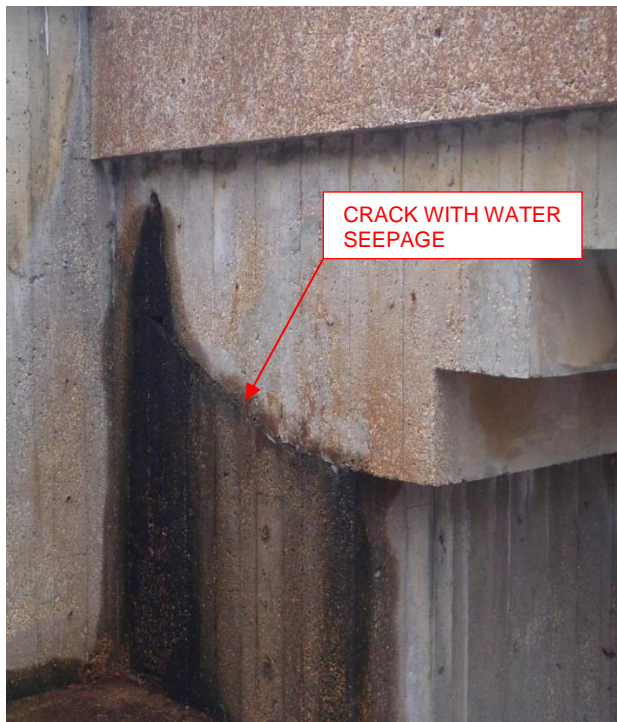
South West plaza (corner of Nicollet Ave and 12th Street): There is one large crack (approx. 1/4") at one of the water features. There was water seeping from the crack and the surrounding concrete was discolored, see photograph 15. At present there is minimal concrete spalling in this location.

Photograph 15: Crack with seepage at SW corner

- At two locations in the edge wall of the pool a joint has severely spalled concrete and rusting rebar, see photographs 15 and 27. It is not clear whether this is a score joint, or an expansion joint. The presence of rebar across the joint, and the fact that the original specifications call out that “All corners shall be built monolithic, the work on each side extending such distances as directed”, indicate that it is likely that the joint is a score joint, and not a true expansion joint. The concrete should be removed in the area and the rebar should be treated with a migrating corrosion inhibitor to prevent further rust forming. The concrete may then be repaired with concrete of similar characteristics.

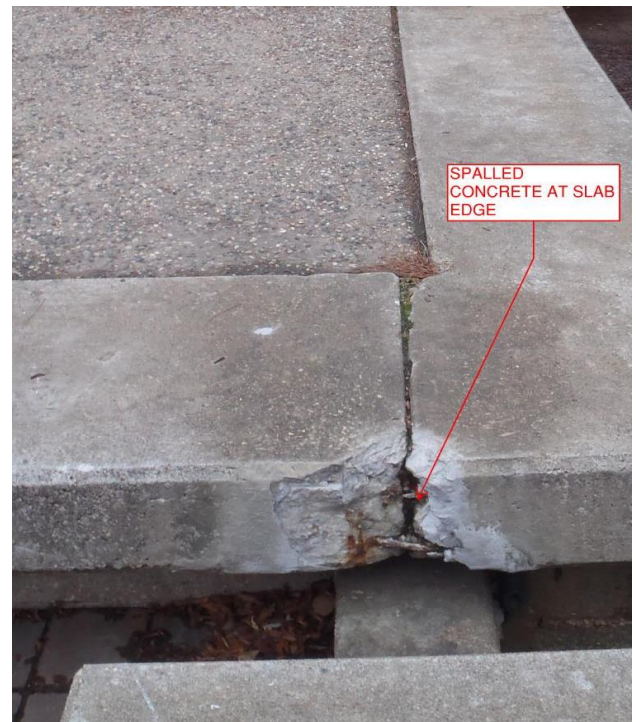
At an expansion joint in the slab edge by the pool there is significant concrete spalling and exposed rebar, see photograph 16. This had been patched, but now the repair has failed too. One of the stepped waterfalls along the 12th Street side has some exposed and rusting rebar, see photograph 17. The concrete spalling is quite localized and was probably due to insufficient concrete cover to the rebar. Along the edge of the sidewalk at Nicollet Avenue there is a row of bollards that has significant cracking in the concrete beam between them, see photograph 18.

Photograph 16: Damage at pool edge

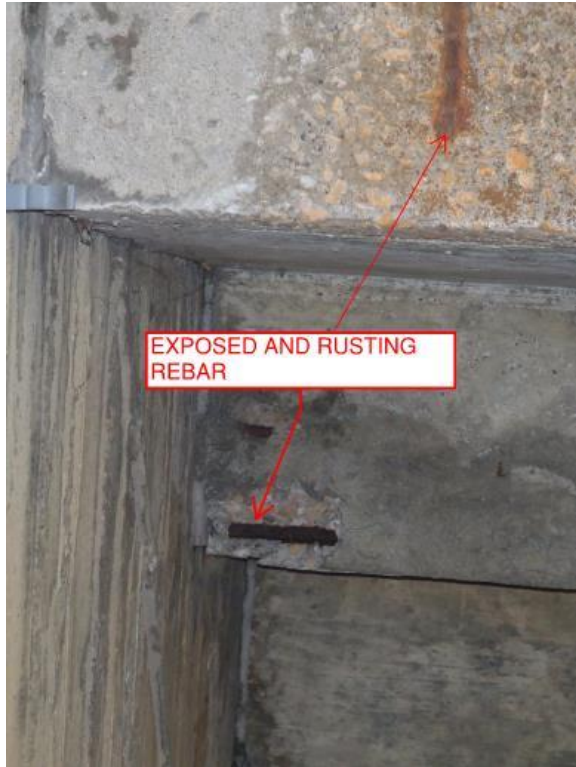
Photograph 17: Exposed rebar

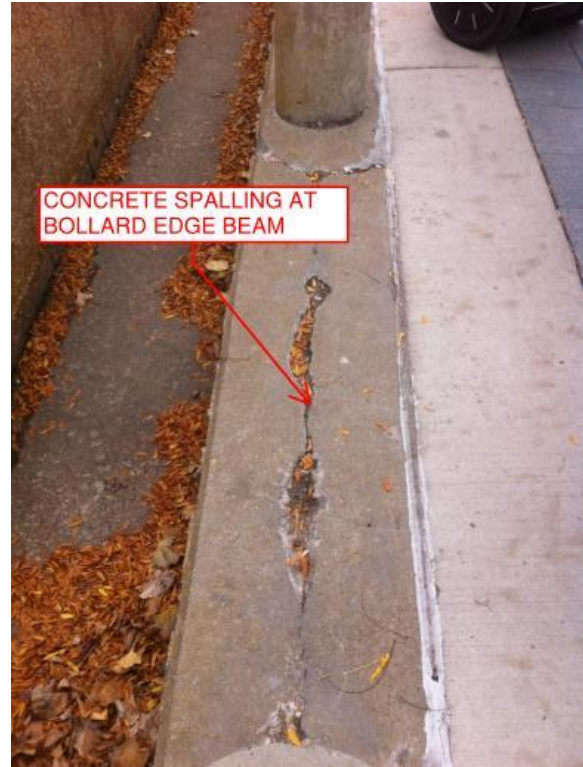
Photograph 18: Cracked concrete at bollards

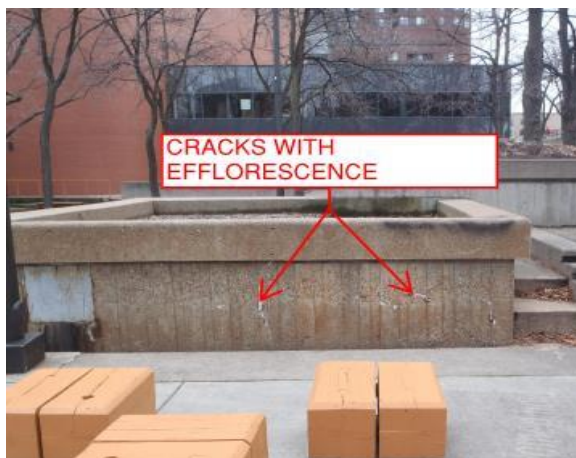
Photograph 19: Cracks with efflorescence

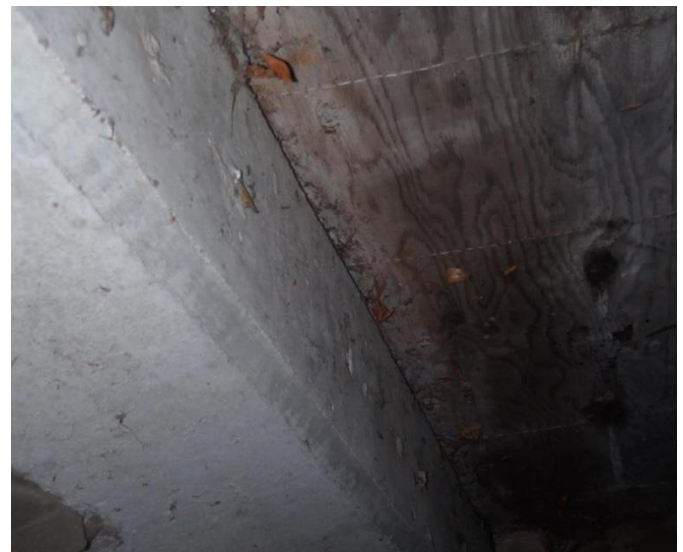
Photograph 20: Underside of small bridge

East plaza (along Concert Hall building): This section has five bridges, several of which are in need of repair. Three of the bridges are approximately 4'-4" wide and 10' long, a section through them is shown in Figure 2. There is little clearance under these bridges and visibility was limited, so the full extent of deterioration could not be viewed. The two southernmost bridges, shown as bridges 1 and 2 on the key plan, are in good condition, see photographs 20 and 21. The southwest bridge, shown as bridge 3 on the key plan, still has its plywood formwork in place, so it was not possible to see the condition of the concrete under the slab. The side walls are in good condition apart from the south east support where the corner of the concrete has been damaged and is missing, see photograph 22. It appears that a repair of this area was attempted, but has failed.

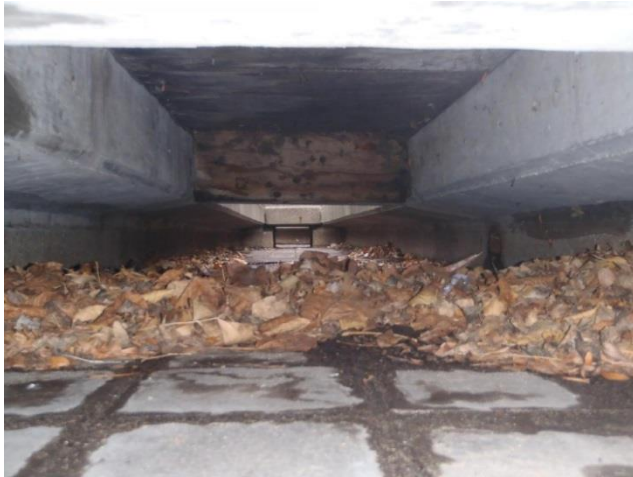
Photograph 21: Small bridge in south of plaza

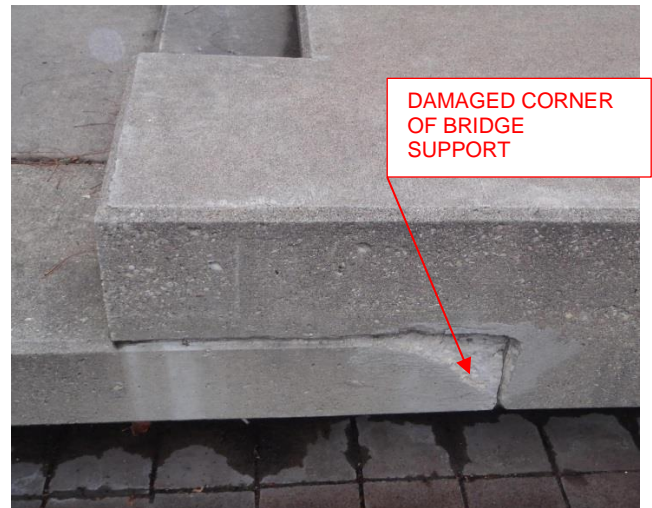
Photograph 22: Damage to bridge wall support

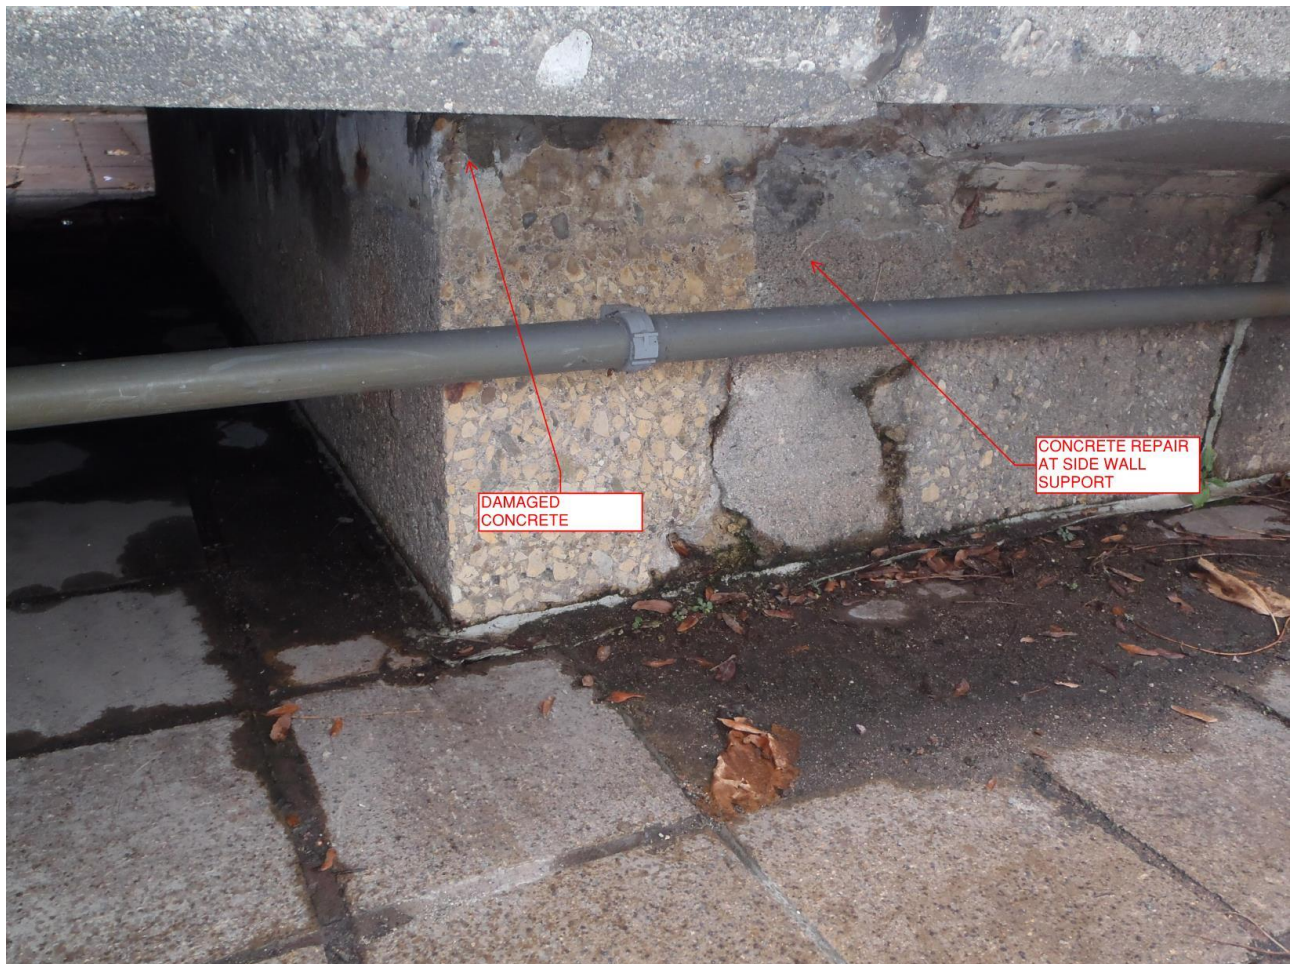
The two larger bridges span approximately 7' and 12'. The shorter bridge, shown as bridge 4 on the key plan, has concrete side walls that have spalled and been repaired, see photograph 23. The underside of the bridge deck also has some spalled concrete, see photograph 24, but it was not possible to determine the condition of the side walls or the deck for the full length of the bridge. The larger bridge, bridge 5 on key plan, is in worse condition than the smaller bridge. In addition to spalling side support walls, see photograph 25, the underside of the bridge deck has severely rusting rebar and spalling concrete, see photograph 26. Again, it was not possible to determine the full condition of the deck or side support walls for the full length of the bridge.

Photograph 23: Damage to bridge 4 side walls

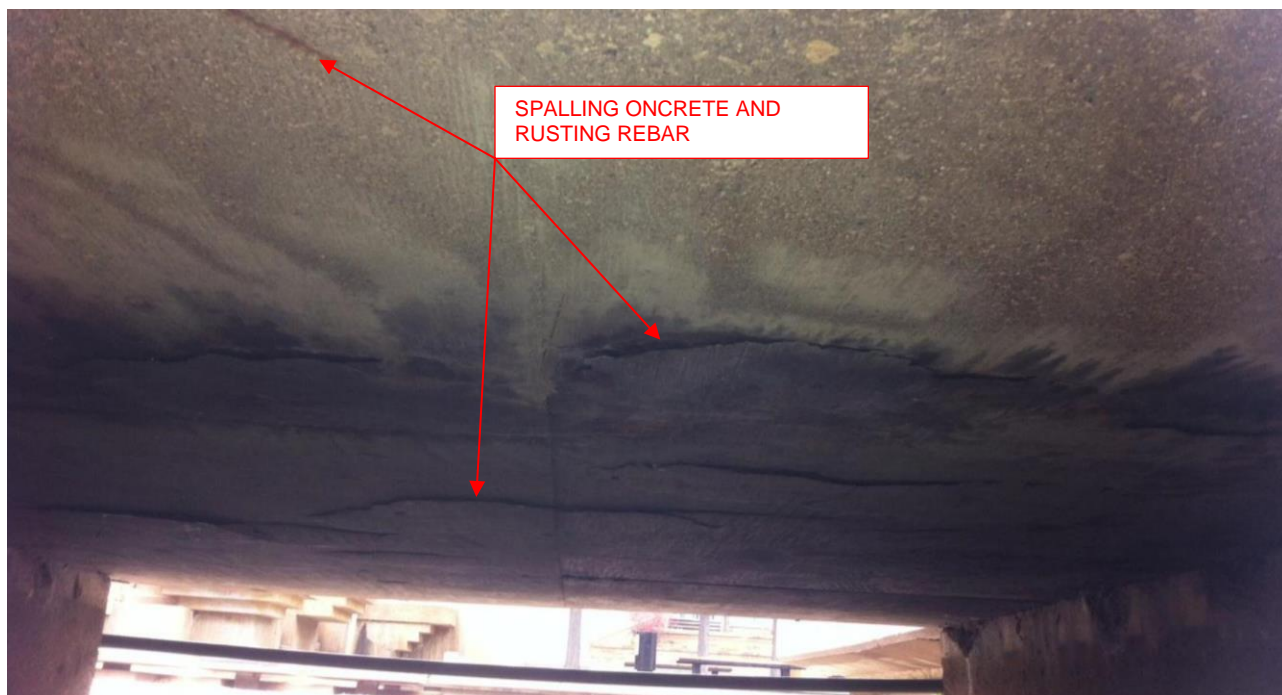
Photograph 24: Spalling concrete on underside of bridge 4

- Bridges: The deck of each of the two long bridges should be replaced. The deck slab is not cast monolithically with the side walls, Figure 5, (Section 8, Sheet SP-9), so it is anticipated that it should be possible to replace the deck without impacting other components of the bridge.

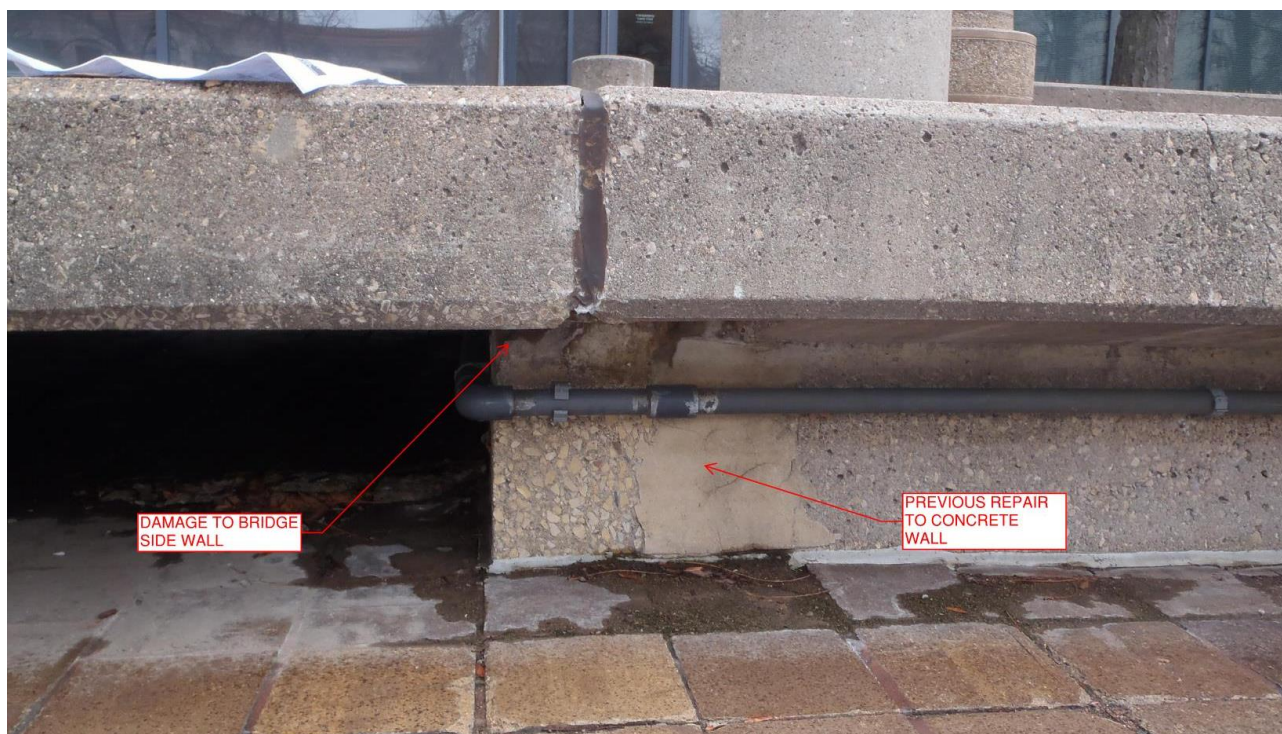
Photograph 25: Damage to side wall of bridge 5

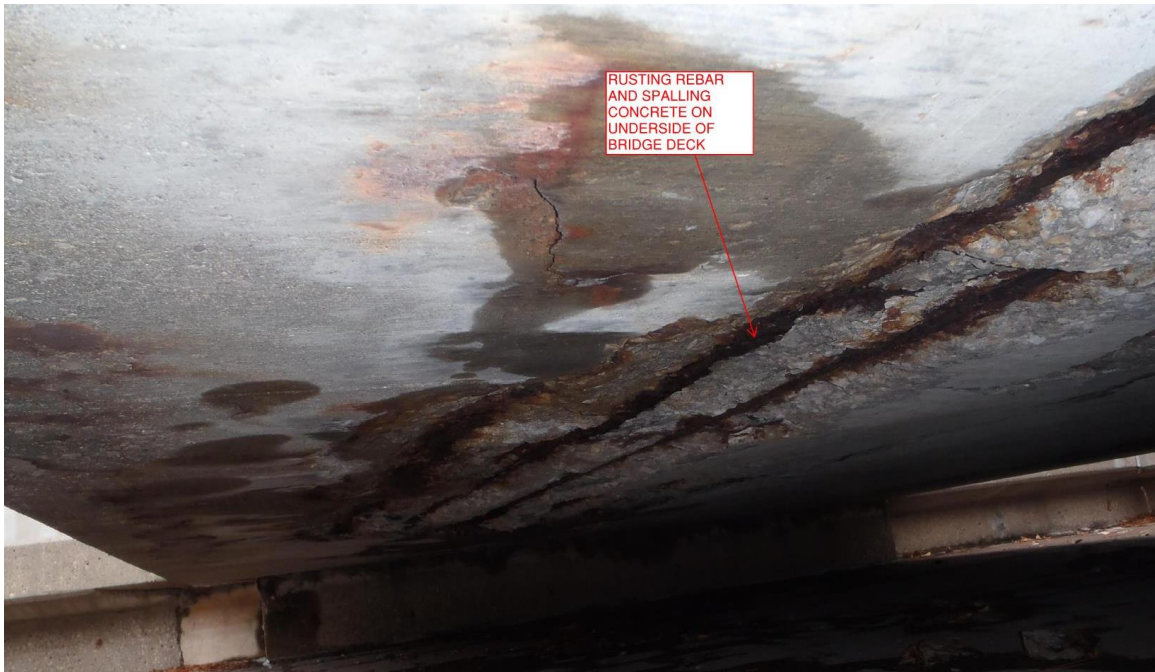
Photograph 26: Spalled concrete and rusted rebar on underside of deck of bridge 5

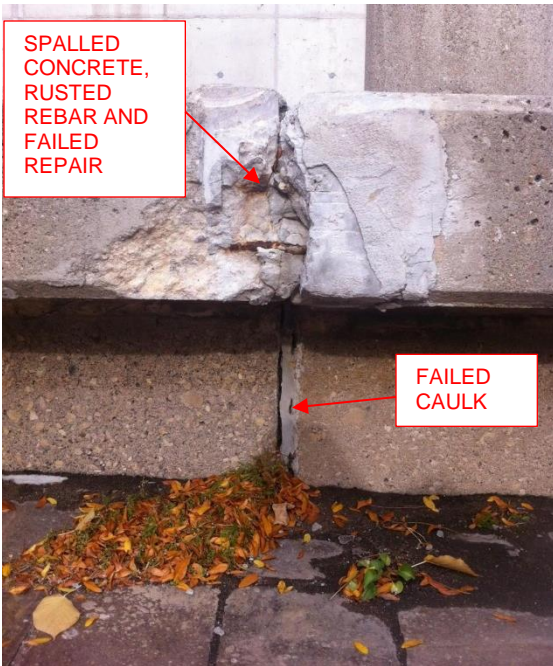
Center North plaza: The main deterioration in this area is at an expansion joint in the pool edge wall, see photograph 27. The damage is similar to that seen at the south west pool edge expansion joint, with rusting rebar, spalled concrete and a failed repair.

Photograph 27: Damage at pool edge

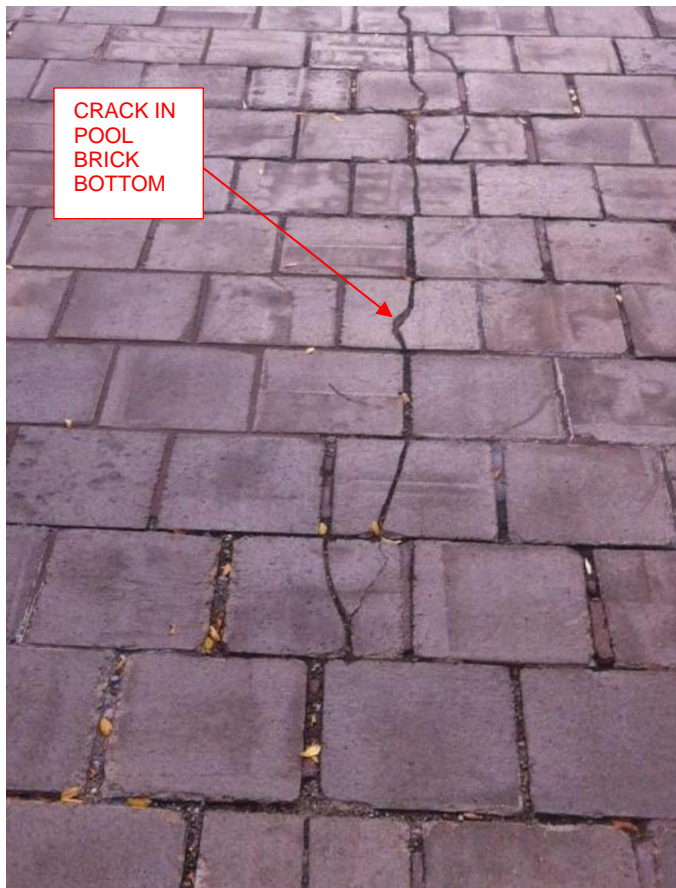
Pool: The brick bottom of the pool is generally in acceptable condition. There is one significant crack running north-south at approximately the midline of the pool, see photograph 28. It is not possible to determine whether just the concrete has cracked, or whether the waterproofing layer below is compromised too. See figure 3 for a detail of the original pool bottom construction. In the East-West direction at the midline of the pool there is a joint between the pavers that has been caulked the full length of the pool, see photograph 29. It is not known whether the waterproofing layer in this area has been compromised as well.

Photograph 28: N-S crack in pool

- **Pool cracks:** At the two locations in the pool bottom where there is cracking, it is necessary to determine whether the water proofing membrane has been compromised. Per the original specifications for the plaza, the water proofing was a liquid applied membrane, see pages 113-116 of the specifications. The elongation is specified to be 500% minimum. This gives an indication that the membrane is capable of considerable deformation, however, whether it ruptured at the cracks needs to be determined.

- Pool cracks: The full extent of cracking in the pool base should be determined as there could be other cracks that are present but less obvious. After determining whether the waterproofing membrane is still intact, the cracks, and membrane if necessary, should be repaired.

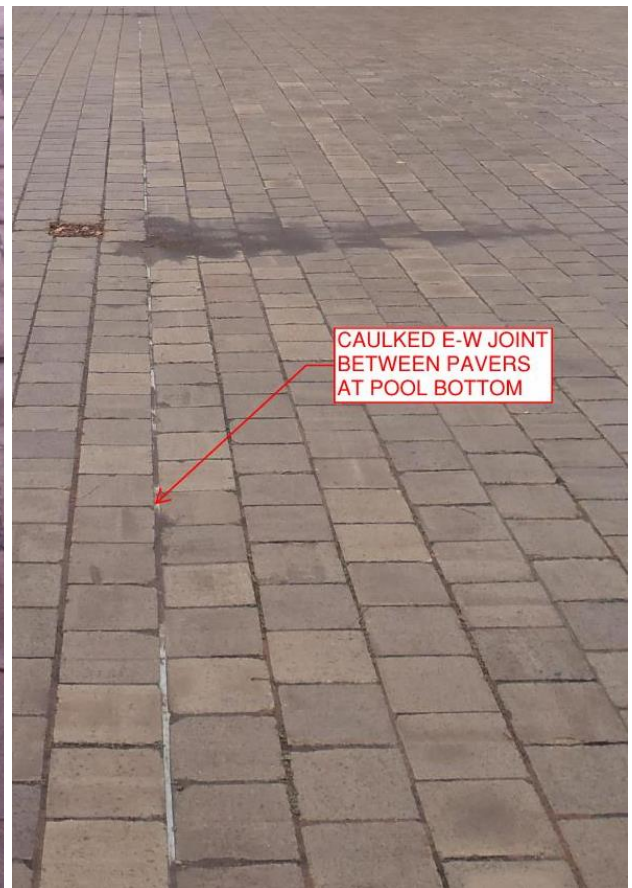
Photograph 29: E-W crack in pool

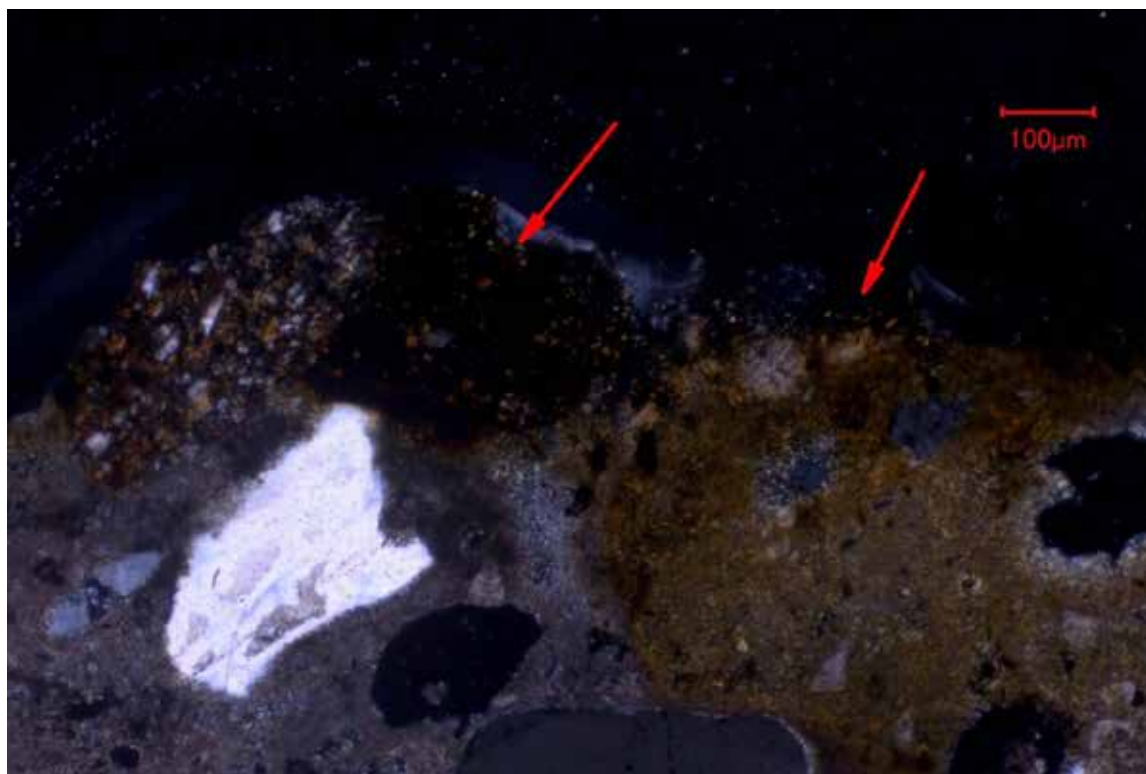
PHOTO: 12

DESCRIPTION: Same area as pictured above, viewed with transmitted cross-polarized light. The top most stained paste is opaque (black). The carbonated paste beneath is stained on the right side of the photomicrograph and unstained on the left side. A layer of opaque paste is typically observed in concrete that has experienced acid attack.

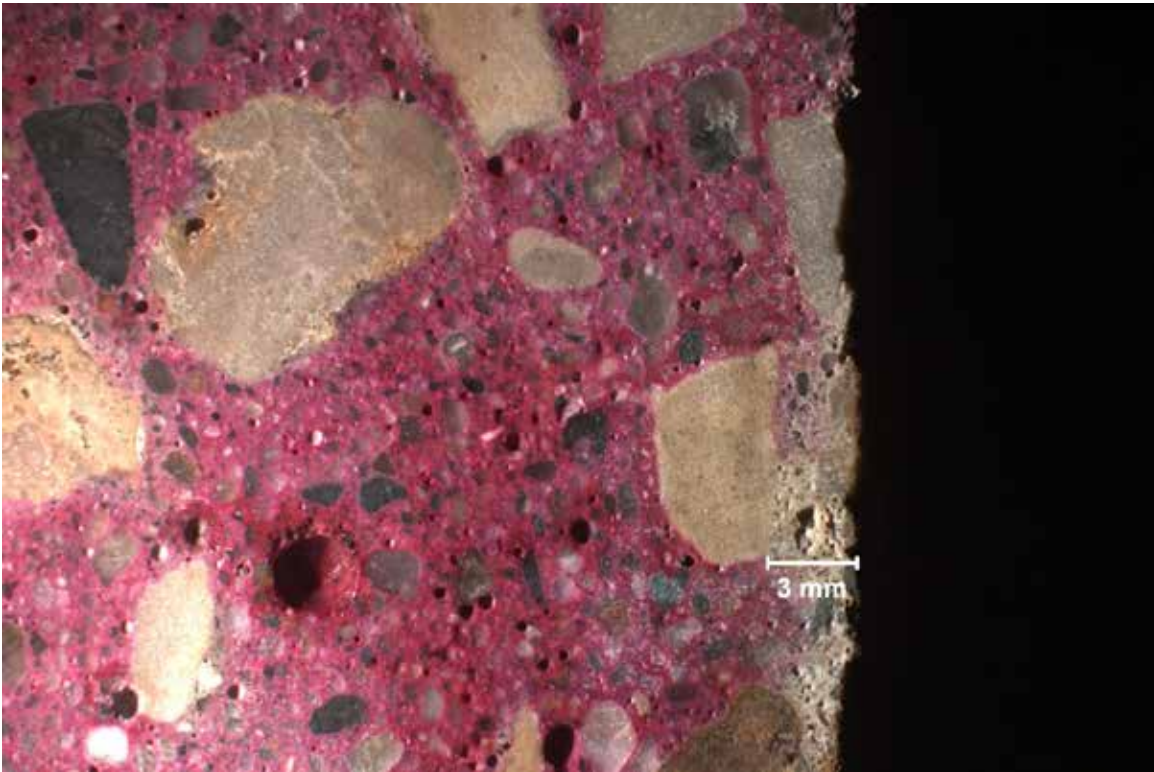
PHOTO: 15

SAMPLE ID:	3	DESCRIPTION:	Carbonation (unstained paste) ranged from negligible to 3 mm (1/8") depth from the outer surface of the sample. Observed on a saw-cut and lapped profile of the concrete treated with the pH indicator phenolphthalein.
MAG:	5x
